TECHNICAL REPORT SL-84-9

# HOW TO AVOID DEFICIENCIES IN ARCHITECTURAL CONCRETE CONSTRUCTION

DEPARTMENT OF THE ARMY  
Waterways Experiment Station, Corps of Engineers  
PO Box 631  
Vicksburg, Mississippi 39180

June 1984  
Final Report

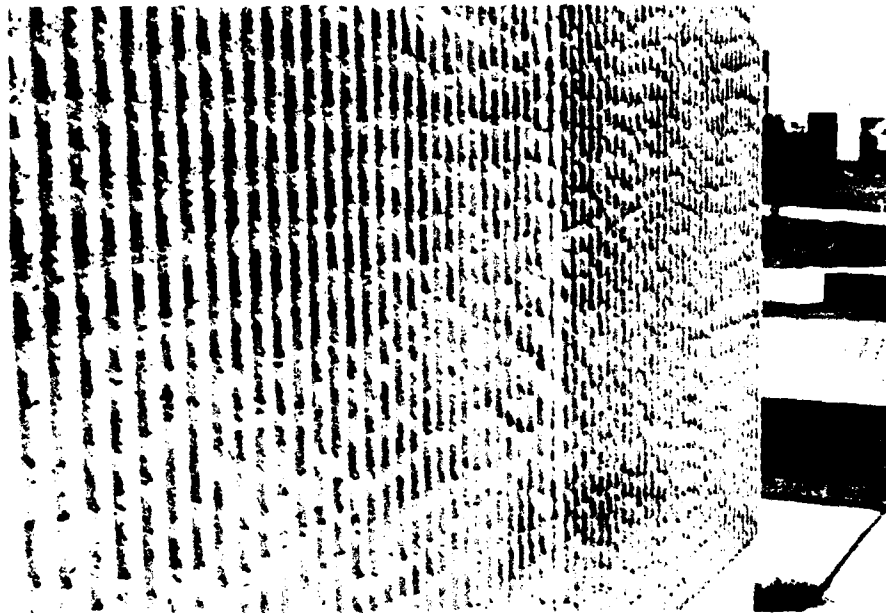
Problem: Precast ribbed architectural concrete with nonuniform sandblasting and substandard fractured ribs

Contrast in color of the two sections due to sandblasting at different angles. Near ribbed section sandblasted at three angles to texture rib sides. Far section sandblasted right angles only. Meandering lines of fractured ribs created by mechanical equipment rather than hammers used manually. Defects indicate inexperienced personnel used in construction and acceptance of panels. Field sample (3 ft by 3 ft) was too small to show possible problems.

Supervision and final acceptance by personnel experienced in architectural concrete texturing. Fractured rib texture is normally made by using hammer manually to fracture rib at uniform spacing in alternate directions. As straight line is difficult to hold with chipping or bush hammering equipment, this fractured texture needed a jig or template. Construction of full-size field sample before production phase is good insurance.

Additional sandblasting required on far section to abrade sides of ribs and uniform the texture and color of both sections. There is no method of altering the present appearance of the fractured ribs.

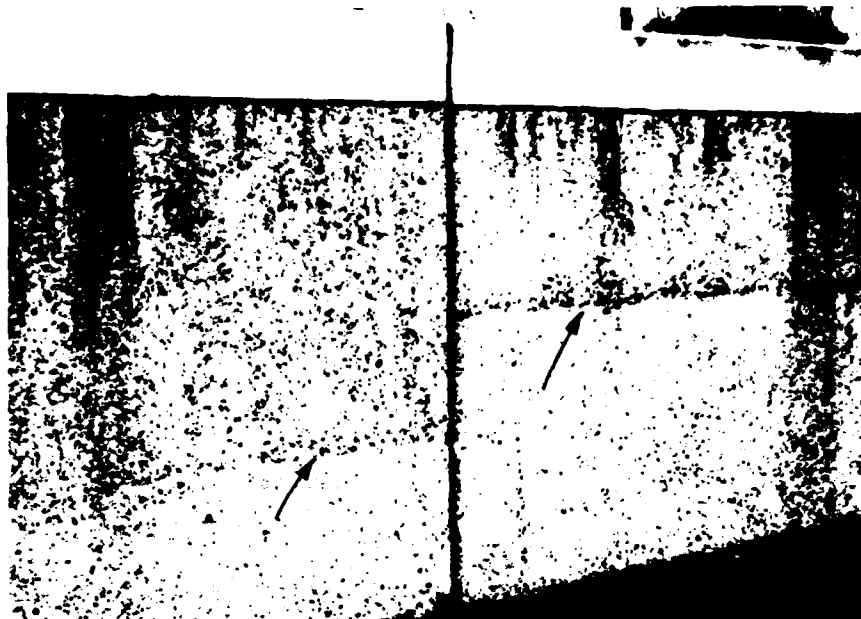
Problem: Offset lift lines in bush-hammered concrete

Project specifications required a change in location of lift line due to shortening of the exposed section of the wall. Form leakage concentrated aggregate at the two lift lines. Subsequent bush hammering exposed the aggregate concentration and accentuated the difference in elevation.

The elimination of the unnecessary construction joint from the plans would have solved the major problem. The leakage could have been prevented by the use of the recommended ACI Committee 303 procedures for such construction joints. Compressible plastic foam gaskets at the bottom of the form have also been used to prevent leakage.

There are two possible methods of repairing the present problem. One is to diminish the effect of the aggregate concentration by applying a cementitious mixture containing matching pigments to the area. After sufficient hardening, a needle gun is used to produce uniform appearance and texture. The second method would be to chip out the concentration and replace with a color matching mixture. Upon sufficient hardening, a light bush hammering along this line would provide the required texturing.
